BRIEFING to MEDIA

**The Malaysian ICAO Annex 13 Safety Investigation Team for MH370
30th July 2018**

**SAFETY INVESTIGATION REPORT
MALAYSIA AIRLINES BOEING B777-200ER (9M-MRO)
8th March 2014**

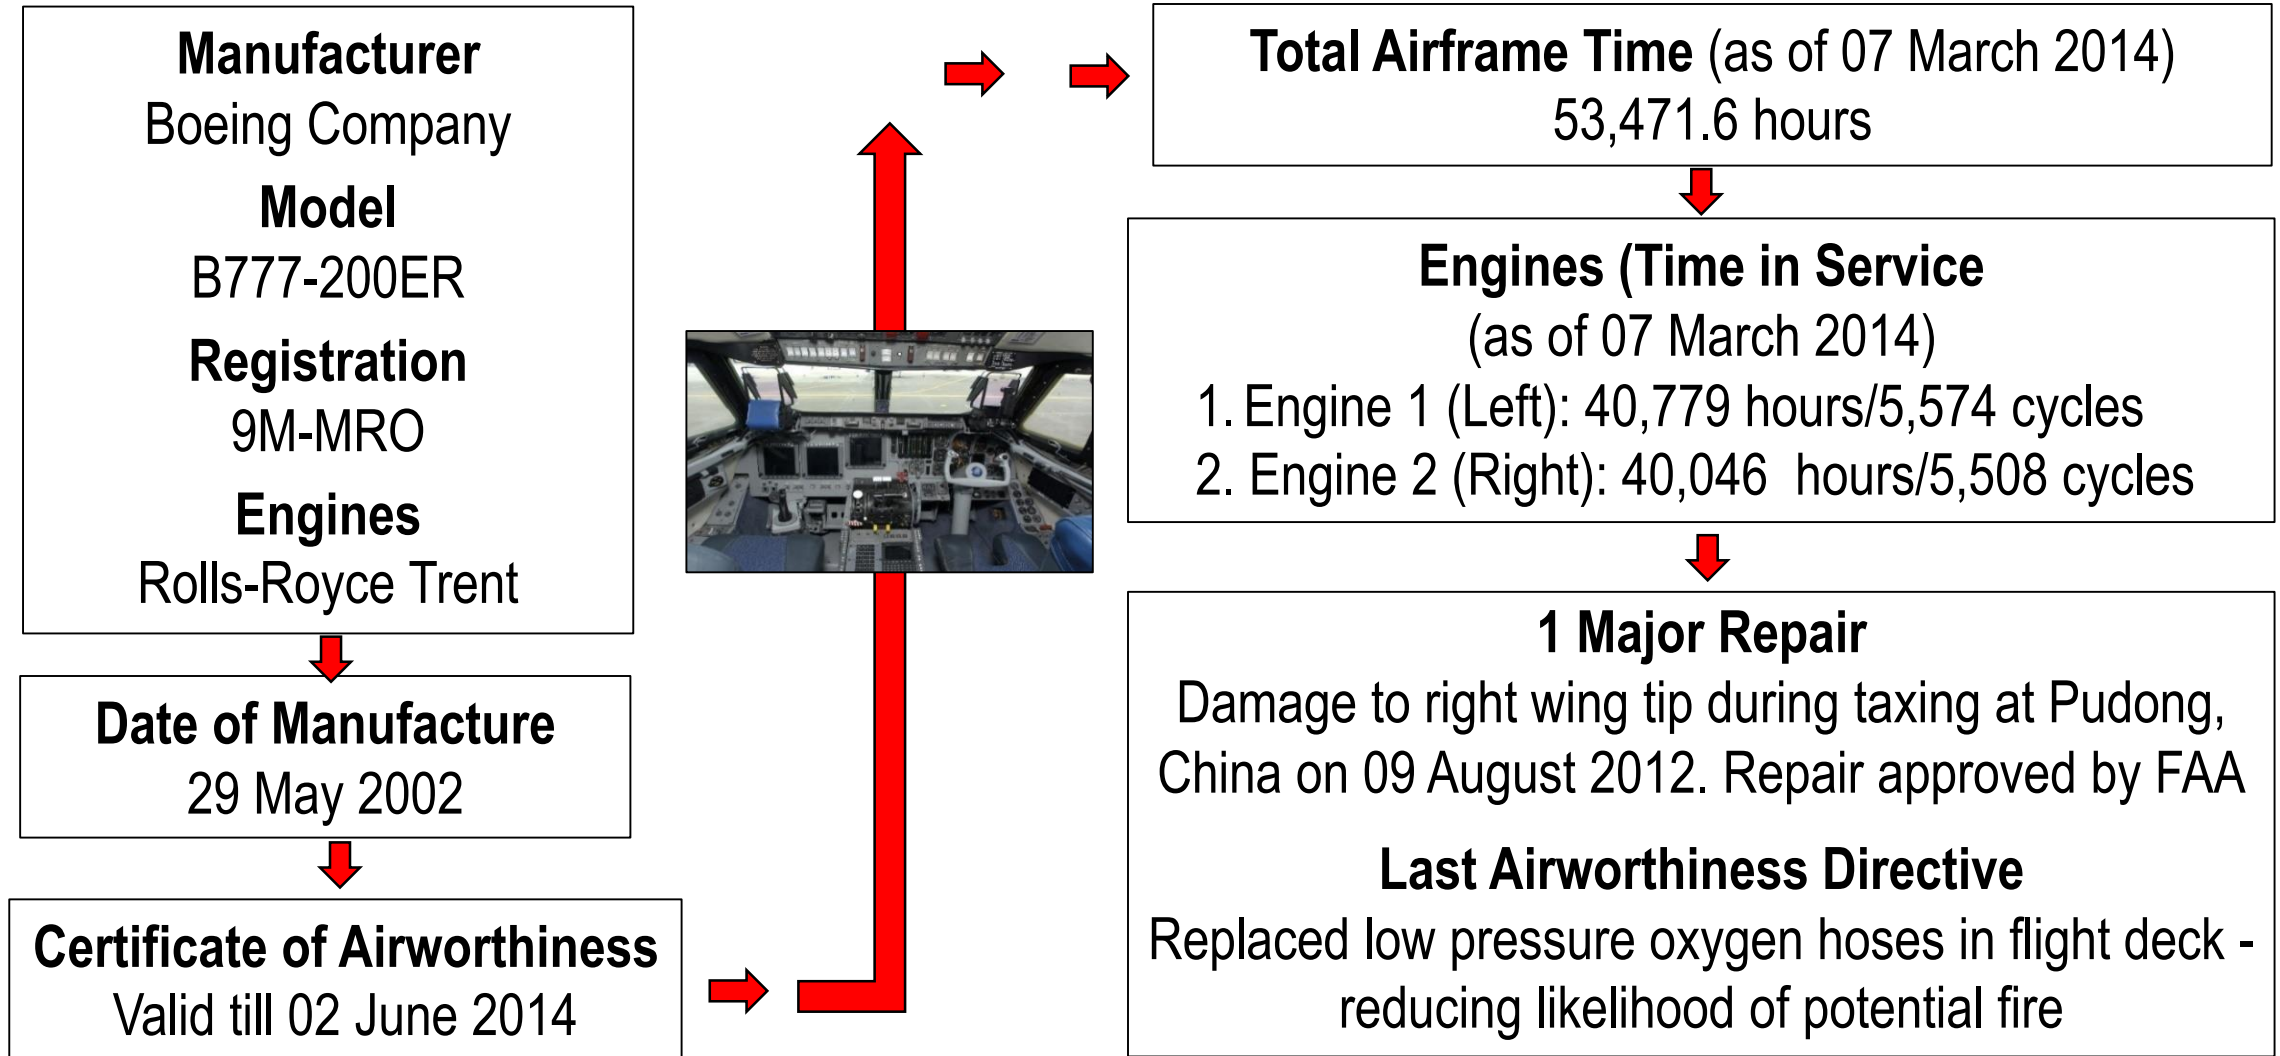
AIRWORTHINESS & MAINTENANCE AND AIRCRAFT SYSTEMS

- 1) Records show all Airworthiness Directives (mandatory inspections and modifications) had been complied with
- 2) Technical Log Review since last D Check in June 2010 shows no significant defect trends
- 3) Engine Health Monitoring (EHM) trend reports over last 3 months show no evidence of unusual engine behaviour
- 4) Two EHM reports, (Take-off and Climb) were transmitted. Both show no unusual engine behaviour)

- 6) No pre-existing defects affecting safety of flight

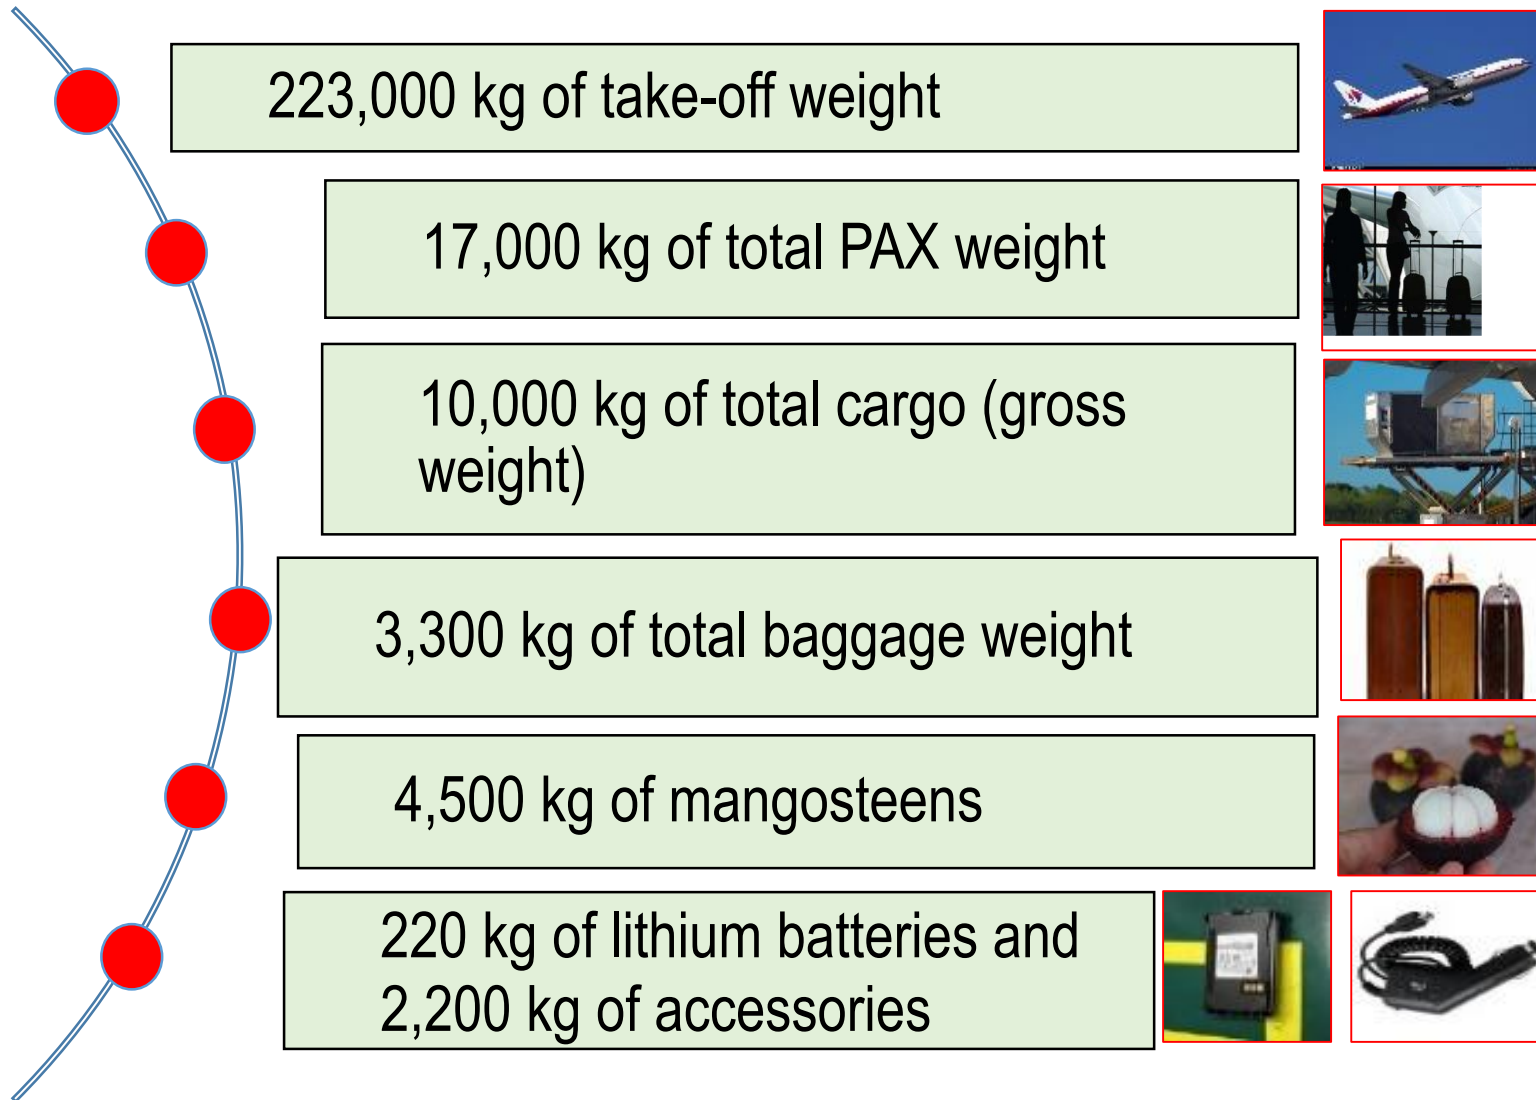
CARGO CONSIGNMENT

- 1) Assembled on 07 March 2014, packed and placed on wooden pallets
- 2) From Motorola forwarder NNR Global Logistics sent shipment to MASkargo Penang
- 3) Battery shipment physically inspected by MASkargo staff but not screened by MAS Security using x-ray machine (then no available x-ray machine large enough to screen cargo in Penang)
- 4) Also went through Customs inspection and clearance
- 5) Li-Ion batteries not classified as dangerous goods because packing adhered to the Guidelines stipulated in the Lithium Battery Guidance Document

- 5) Fruits put into ULD, checked by Federal Agricultural Marketing Authority (FAMA) and MAS and loaded into aircraft - 4 ULDs used
- 6) A total of 85 shipment to China from January to May 2014
- 7) Regular consignment for the past few years
- 8) No irregularity in packing process
